OCMULGEE ASSOCIATES, INC.

Reference: Stonehurst, Paine Estate, Waltham, Massachusetts  
OA File 20016.1

**ATTIC SHED ROOF  
WALL REINF DETAIL**

Reference: Stonehurst, Paine Estate, Waltham, Massachusetts  
OA File 20016

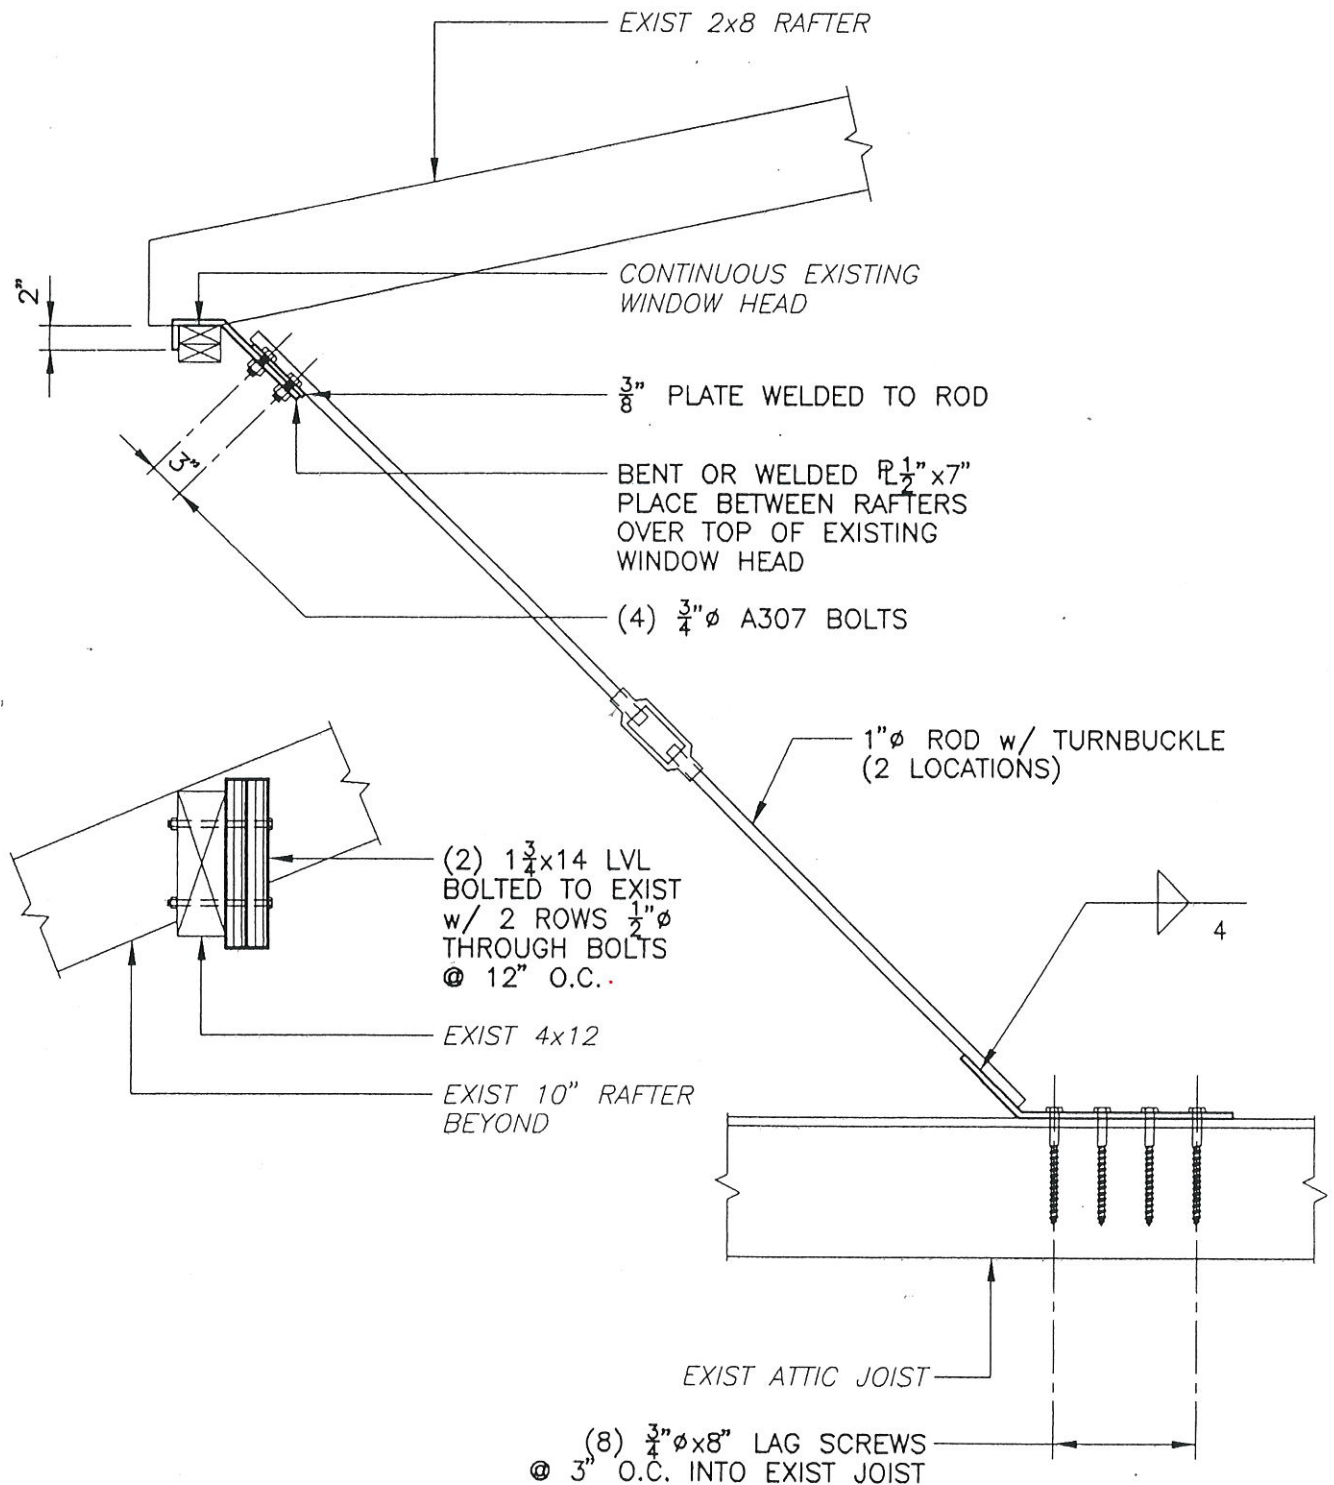
**SKS-1**

3. The window wall of the south-facing shed dormer has leaned outward. The wall and the portion of the roof sitting on the wall are not supported on the attic floor but rather on a low 4x12 header beam under the windows. The beam frames into the rafters on both sides of the dormer. If the full 30 psf snow load is placed on the roof, the beam would be severely overstressed. As a practical matter, the snow probably slides off the metal seam roof before it can significantly accumulate.

The tilt in the window wall is probably not related to the undersized beam. Because there is no ridge beam, the roof is unbalanced. The steeply sloping north roof leans against the shallowly sloped dormer roof and pushes it over. Theoretically, the roof framing is unstable at the shed dormer. However, the roof sheathing probably redistributes the loads and restrains further movement.

We recommend that the 4x12 beam under the windows be reinforced with two 1-3/4"x14" sisters and that diagonal steel tie-rods be added in the attic space to brace the window wall. The tie rods would go from the top of the window wall down to the attic floor at about a 45 degree angle.

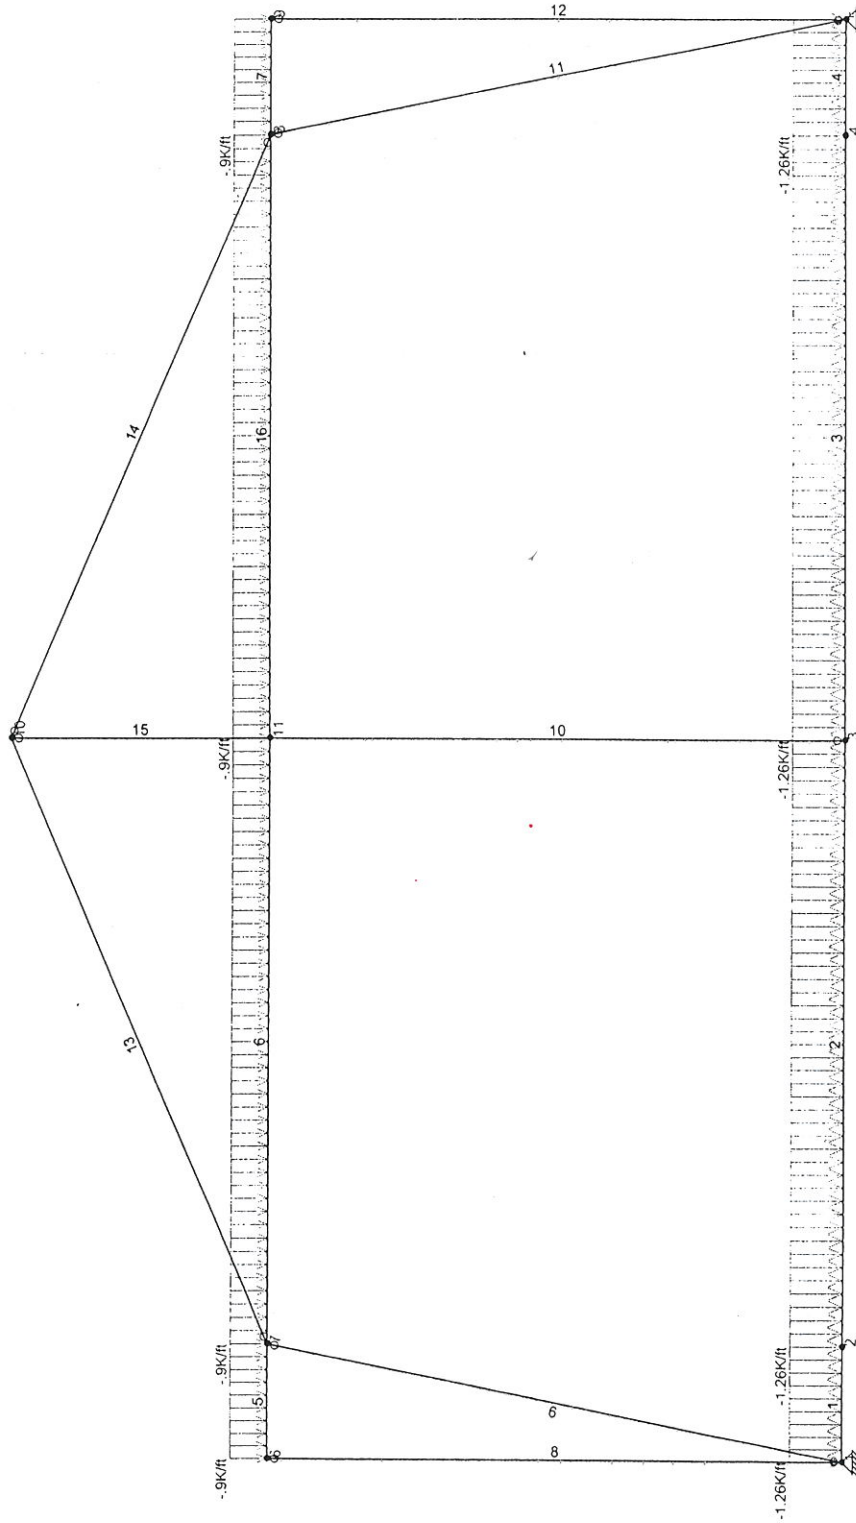
Ocmulgee Associates, Inc. Wayne C. King 20016.1	Paine Estate, Stonehurst Pony Truss		March 3, 2001
			3:34 PM
			PainePonyTruss.r2d

1. During our original inspection on January 27, 2000 we noted that the pony truss in the attic was built in a manner that resulted in the diagonal members intersecting the horizontal tie beam several feet away from the vertical supports. An engineering analysis indicated that the horizontal tie beam would be seriously overstressed at the intersection points. Therefore, we requested that a closet wall be opened so that one of the intersection points could be revealed and inspected for any damage or any reinforcement that might be present. This opening was made and yesterday we observed that a sloping column had been introduced by the builders between the second floor and attic, running from the main column up to the intersection point on the pony truss.

Based on this information, a revised engineering analysis found that all of the structural members (pony truss elements, columns, second floor beam, tie rod) are stressed within allowable limits under the full dead and live loads required by the Massachusetts State Building Code.

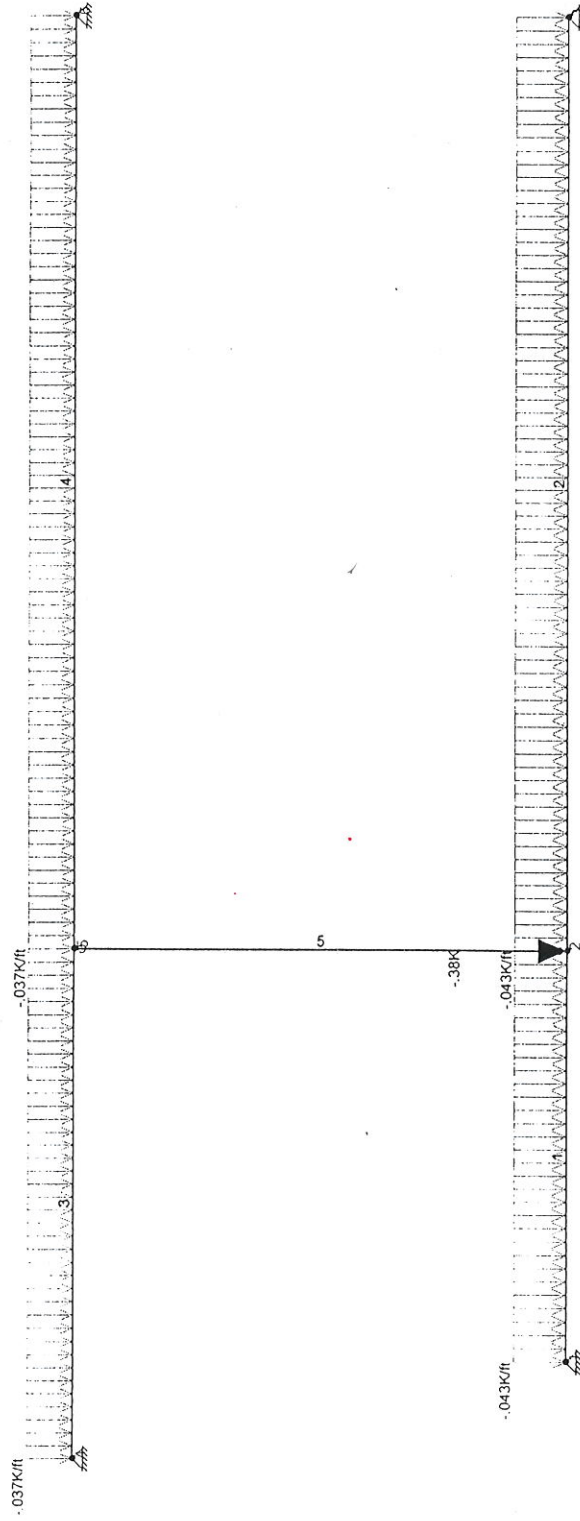
Paine Estate, Stonehurst Mansion

2. A visible deflection is present in the second floor under the corridor wall at the southeast bedroom (Mrs. Paine's bedroom). The wall on the north side of the corridor is a continuous bearing wall from the basement to the attic but the wall on the south side of the corridor sits on the second floor and is present only between the second floor and attic. The engineering analysis that we made last year indicated that the joists were highly stressed under the loads required by the present building code but that the stresses are not necessarily unsafe. Insofar as our analysis was based on old drawings and written information from previous reports, we requested that an opening be made in the second floor so that the joists could be inspected and any signs of cracking, notching or other distress could be discovered. The joists were exposed at a hot air floor grate and yesterday we observed that the wood is a finely-grained pine (hard pine was specified in the original construction drawings) with small, tight, widely spaced knots. Checking is limited to a hairline crack at the midheight of the joists. The wood is probably equivalent to a modern Select Structural grade with a safe allowable stress approaching 1,600 psi. Except for a one inch deep notch in the bottom of the joists where they override the bearing wall, the joists are full depth at their supported ends.

Setting up a computer model to represent the second floor joists, corridor wall and attic joists as a structural system acting together, we found that the attic framing more or less supports the dead load of the attic for the typical 27 foot distance across Mrs. Paine's bedroom and the corridor.

However, the bearing wall on the north side of the dressing room is shifted two feet to the north from the line of the typical north corridor bearing wall such that the attic joists must span 29 feet across Mrs. Paine's bedroom and the dressing room. This additional span doubles the attic floor load on the wall on the south side of the corridor. Although the attic floor load on the wall is relatively small, there are additional dead loads present to locally raise the stresses and deflections in a few joists near the entry door into Mrs. Paine's bedroom: the wall into the dressing room; and large wardrobes on both sides of the south wall. The observed deflection is further aggravated by the effects of creep under sustained dead loads; that is, the initial, calculated deflection will gradually double under sustained pressure even though the stresses remain the same. This appears to be what has occurred in the area we observed. One component of the aggravating dead load is the 1-1/2 inch thick sound deadening mortar seen between the joists on both the second and attic levels. This mortar represents about 40 percent of the dead load.

Based on our load and deflection analysis, we recommend that no live load, i.e. stored items, be permitted in the attic and no more than 15 people be allowed in Mrs. Paine's bedroom at any one time. The attic should be posted with signs warning that no loads should be placed east of the pony truss discussed in item 1, above.
