LANDSCAPE MASTER PLAN UPDATE

ROBERT TREAT PAINE ESTATE

PREPARED FOR
City of Waltham and
Robert Treat Paine Historical Trust

June 1999

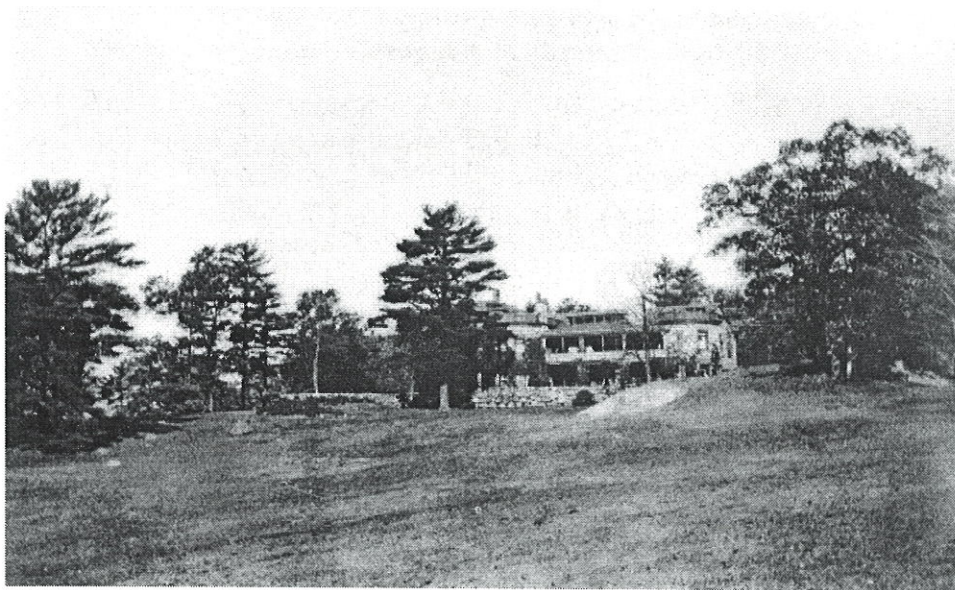
*Images such as this pre-1910 view reveal the openness and simplicity of the original landscape design.
(Source: Elizabeth Paynter Storer)*

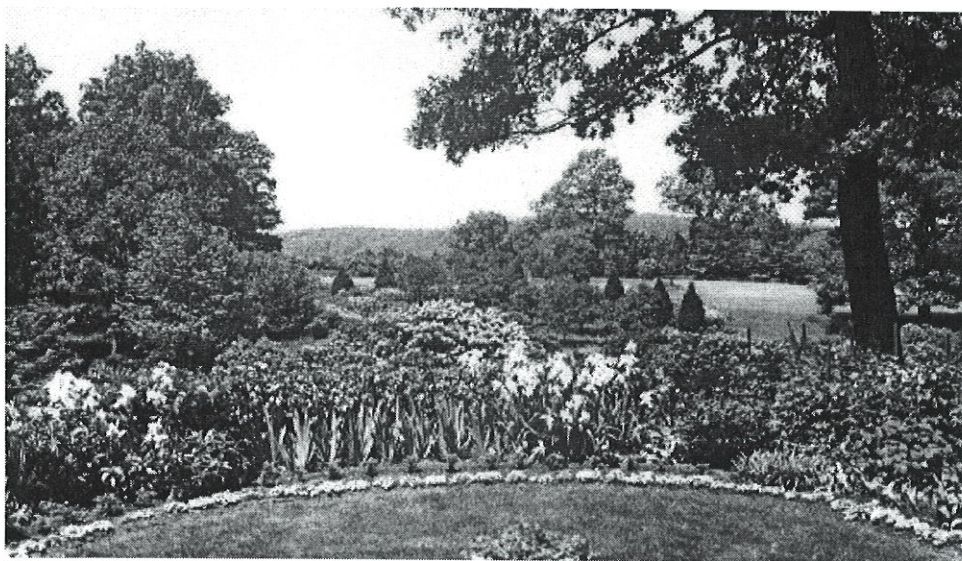
Paine Jr. introduced extensive ornamental plantings throughout the landscape, most of which have disappeared. This view is looking west with the terrace in the foreground and the west lawn beyond. (Source: Robert Treat Paine Estate Archives)

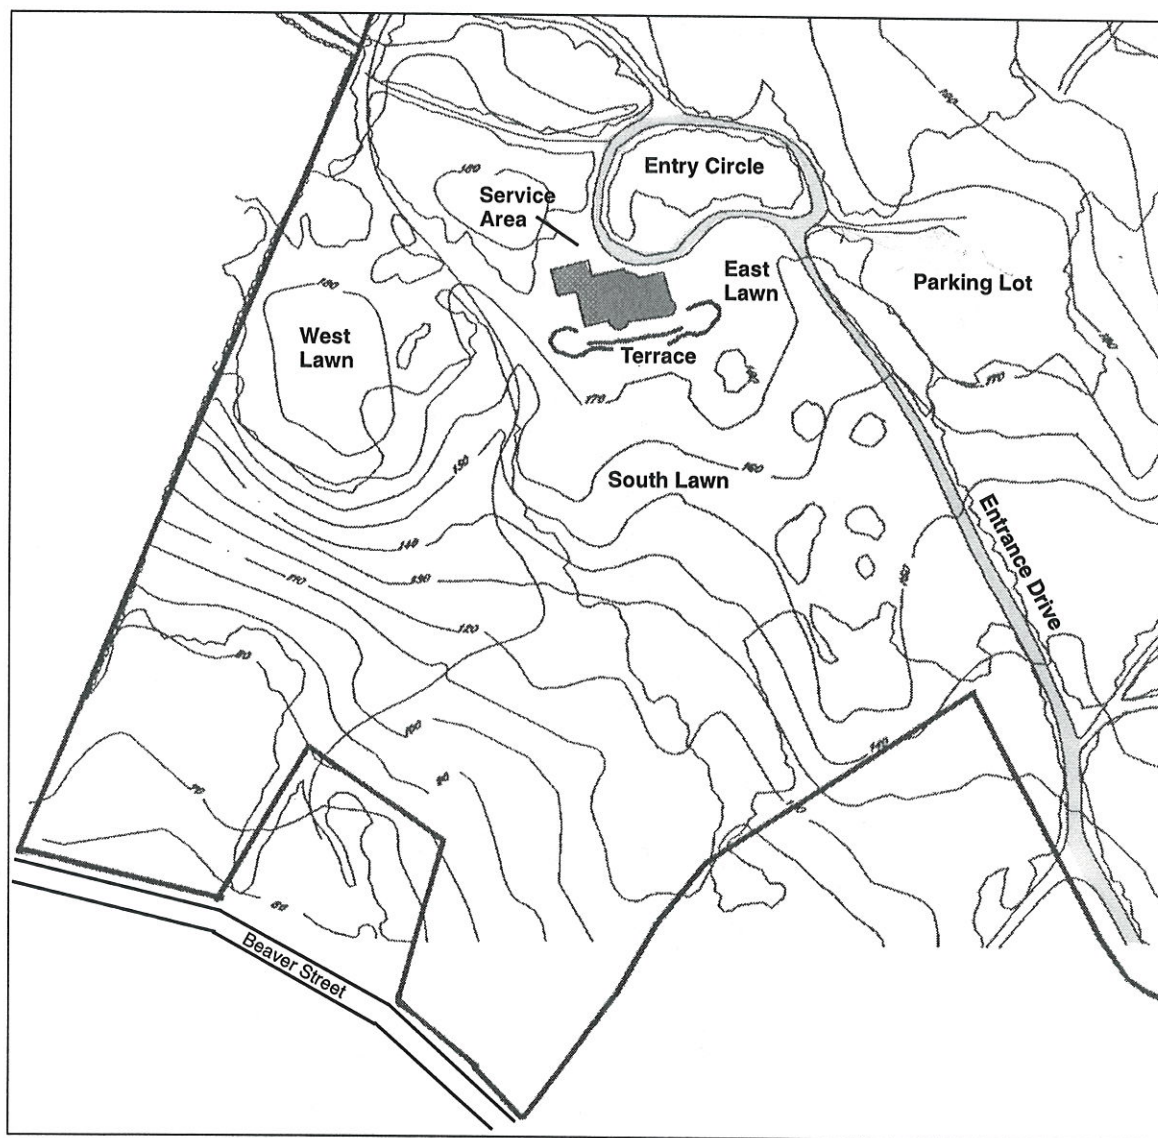
Detail of historic core area showing landscape areas. North is at the top of the map. (Source: "Historic Grounds Report")

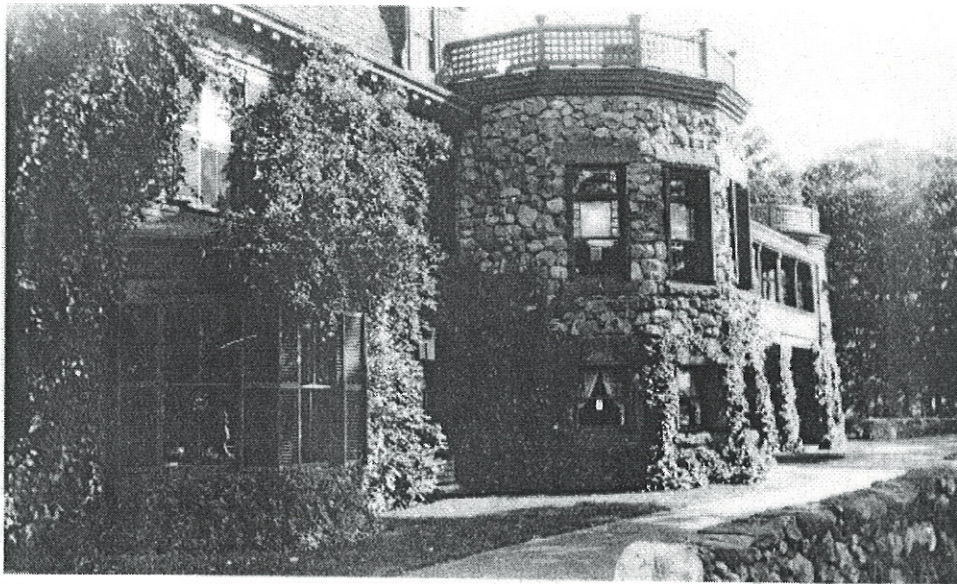
*This 1905 view shows the simplicity of the early terrace plantings and the use of vines on the structure.
(Source: Elizabeth Storer Paynter)*

The terrace is the most visible and heavily used portion of the landscape. The short-term goal for this area is to reduce planting beds to the two ends of the terrace and to maintain an attractive appearance which requires as little maintenance as possible. The long-term plan is to eliminate planting beds on the terrace altogether and to re-establish the original brick configuration, recreating the appearance of the terrace in the pre-1910 period.

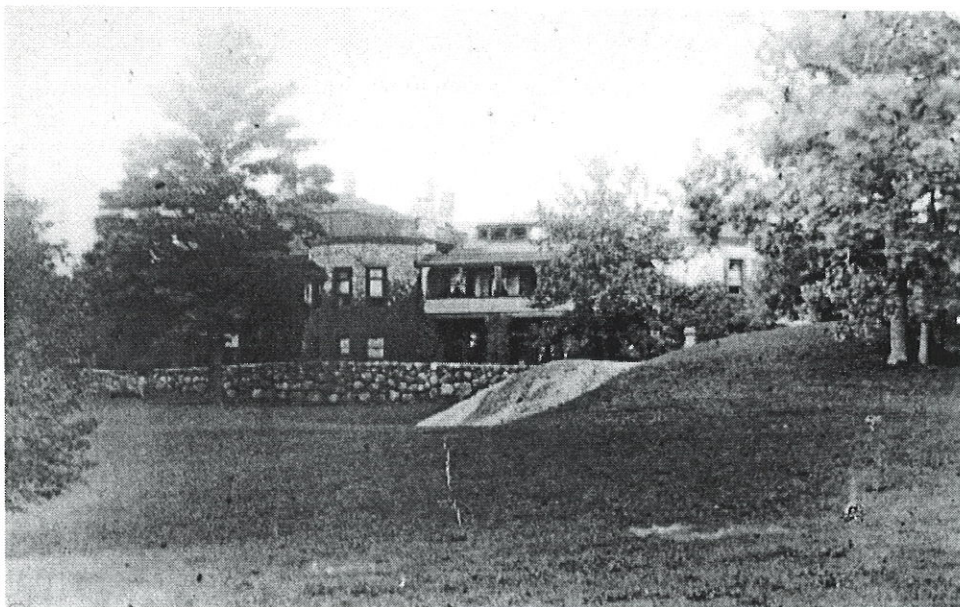
Once the south lawn has been cleared, photos such as this 1890s view can be used to guide grading and replanting. (Source: SPNEA)

Work to be undertaken in summer 1999 will begin the process of opening up the full south lawn. Additional follow-up work may be needed depending on the results of the first project.

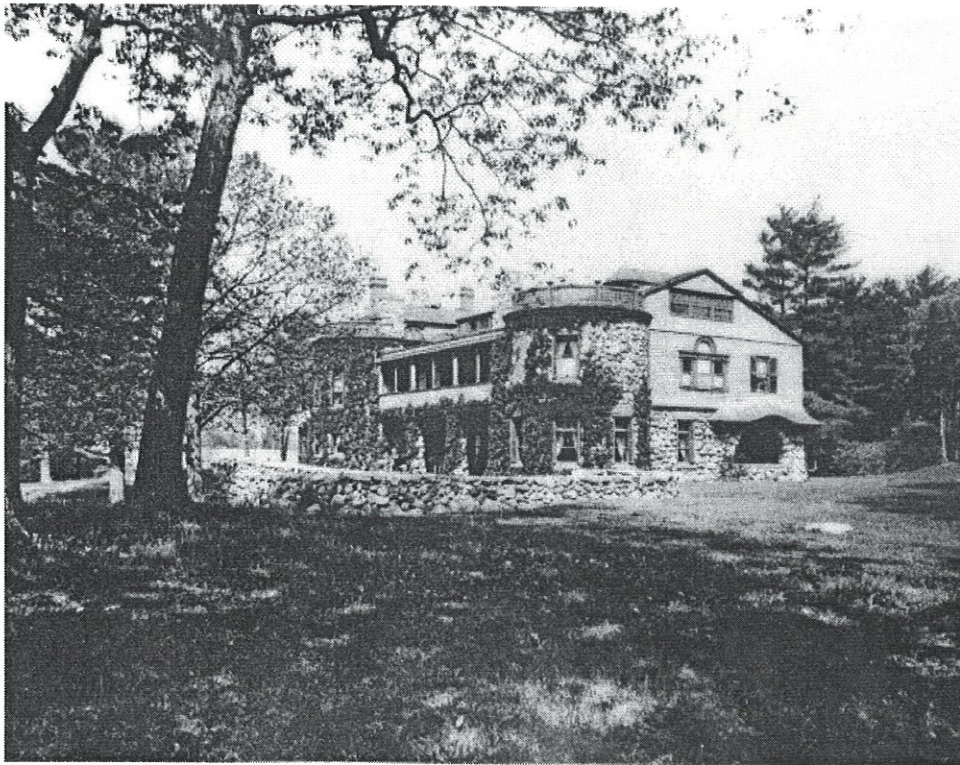
View of terrace from east lawn, 1890s. During the Robert Treat Paine Sr. period, the terrace walls were exposed rather than covered with vegetation. (Source: SPNEA)

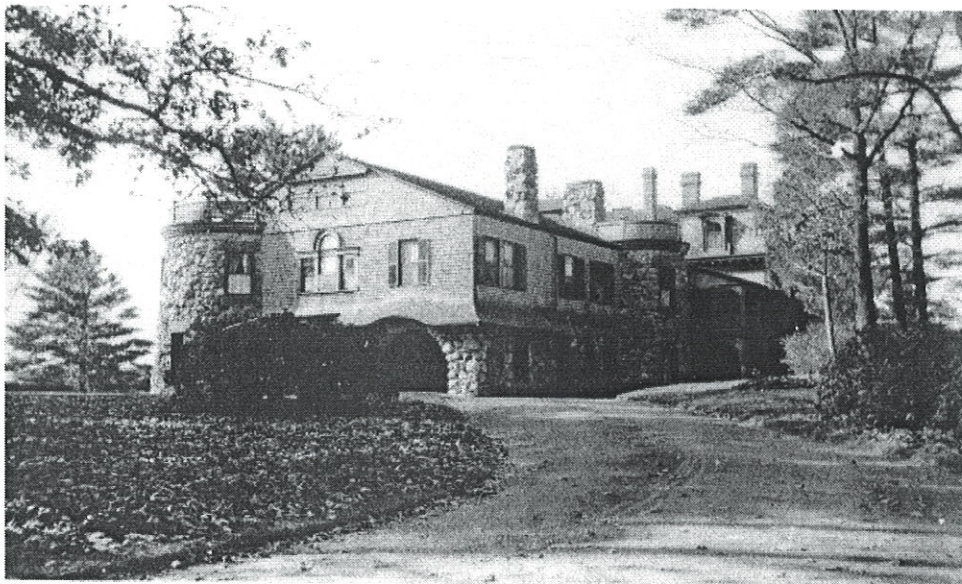
This early image shows the original character of the entrance drive as it nears the house, with graveled surface, well-maintained turf to the edge of the road, and carefully placed shrubs to frame views. (Source: Shepley, Bulfinch, Richardson and Abbott, no date)

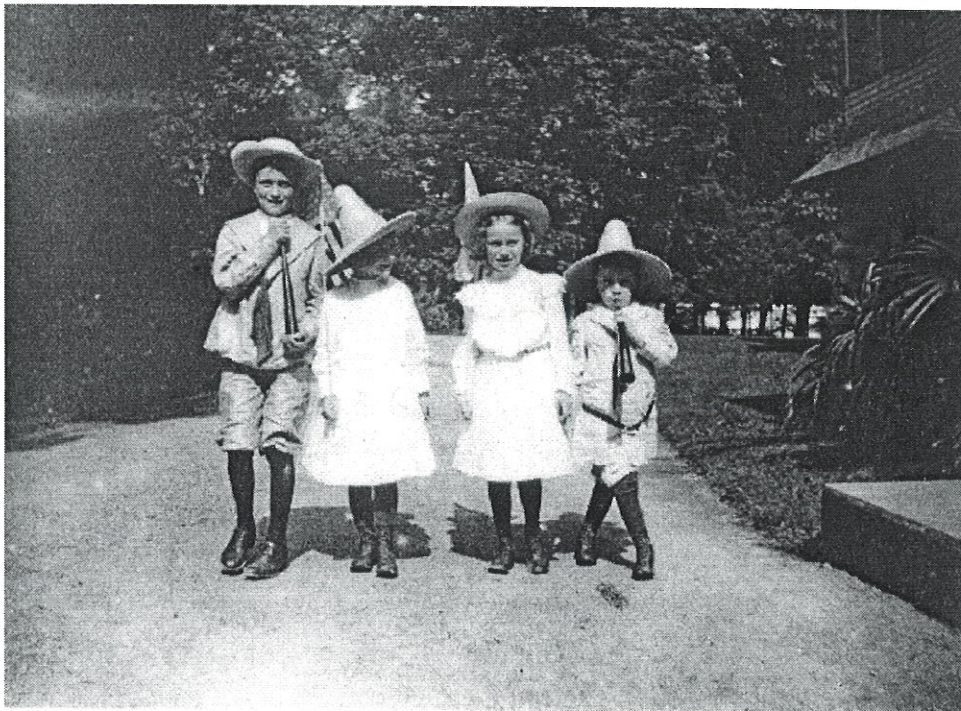
This 1905 view of the Paine children shows the carefully-maintained entrance drive. (Source: Elizabeth Storer Paynter)

The road needs to be repaved for vehicular safety and to eliminate erosion. The general approach should be a sensitive rehabilitation which would respect the character of the initial roadway alignment, views and plantings but adapt it to current needs. The 1992 "Landscape Master Plan" recommended that the current one lane width be retained. This decision may need to be re-evaluated in light of current usage and safety standards.

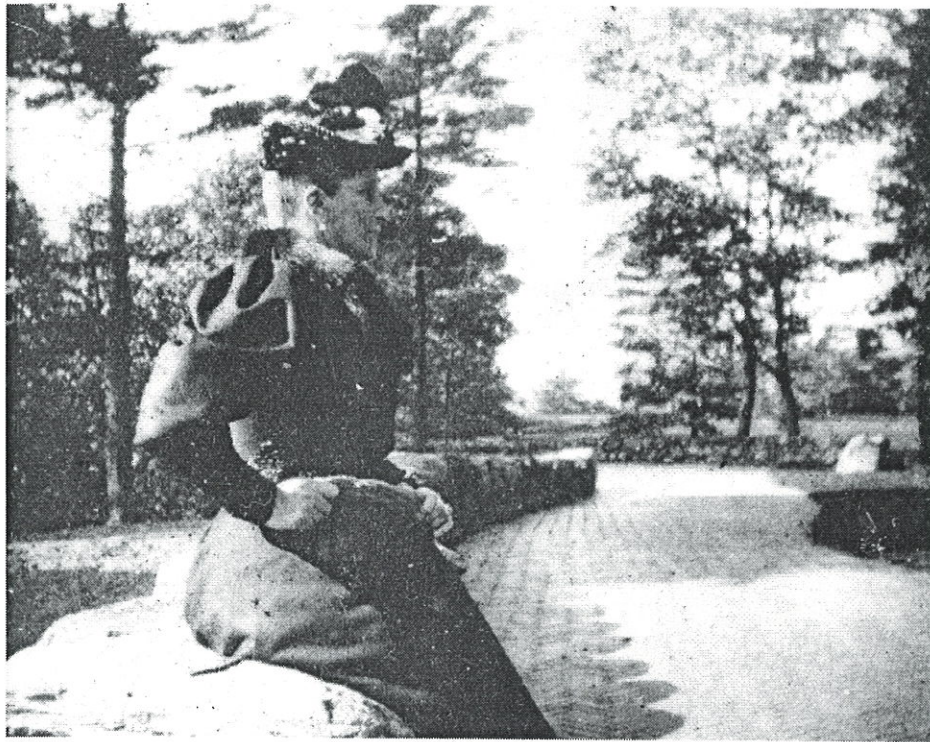
*This 1897 view, looking west along the terrace, with Lydia Lyman Paine in the foreground, provides some information about the original paving, but also leaves many questions unanswered.
(Source: Robert Treat Paine Estate Archives)*

Olmsted's sketches show several options for surfacing the terrace but definitive plans have not been found. Early photographs show herringbone patterned brick covering most of the terrace with some small areas of turf. Edges appear to be somewhat undulating, echoing the lines of the terrace. The only other terrace plantings which appear in early images are yuccas and other ornamental species in iron pots. Thus the initial appearance of the terrace was much starker than it is today. Sometime between 1905 and 1932 the brick area was reduced to a relatively small rectangle in front of the loggia with the remainder turfed, with perennial beds at the ends. The current configuration and surfacing has evolved from this latter approach.

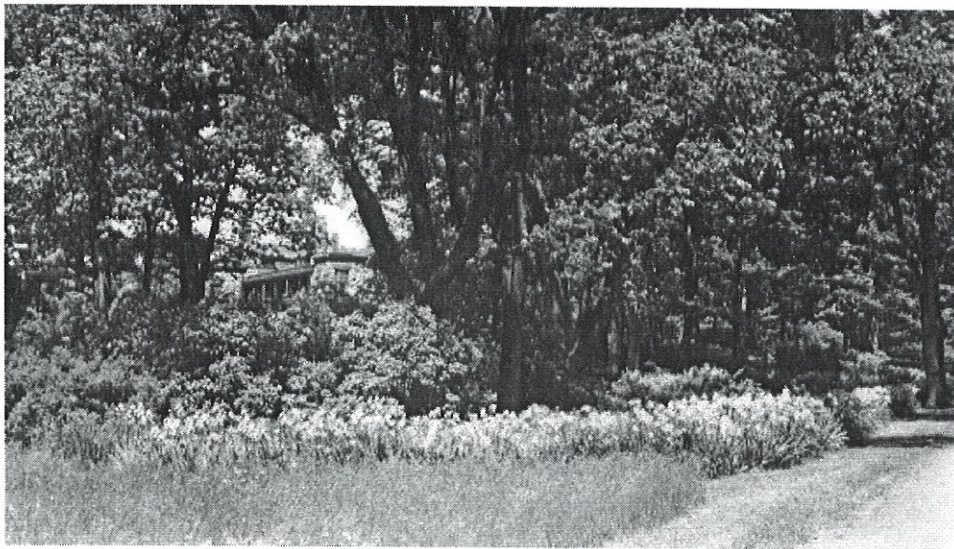
*This view of the entrance drive, which dates to the Paine Jr. period, shows the selective views of the house and layered roadside plantings that characterized the road during this period.
(Source: Robert Treat Paine Estate Archives)*
